# FACILITY STATUS CHANGE FORM (for DOE/RL-2010-34 Facilities)

ate Submitted:	Area:	Control #:
April 1, 2014	100-N	
Originator:	Facility ID:	D4-100N-0059
Clay McCurley	181N Cable Float Barriers	
Phone:	Action Memorandum:	
942-8928	0	
This form documents agree	General Hanford Site Decommission	
the disposition of und	lerlying soil in accordance with the	w on the status of the facility D&D operations a applicable regulatory decision documents.
		representation decision documents.
Section 1: Facility Status		
All removal actions re	equire by action memo complete.	
Removal actions requ	ired by actions memo partially comple	ete, remaining operations deferred
		g sporadono delened.
recollidition and Decomm	tivities and Current Conditions:	
arriers prior to demolition. A r	eview of past uses of the harriogs in the	ere present on rebar reinforced concrete cable float cated chemical and/or radiological contamination
ighly unlikely. Visual examina	tion of the barriers identified no stainir	cated chemical and/or radiological contamination ng and pre-demolition radiological scoping surveys

This document provides information regarding the history, characterization, and final status at the comp

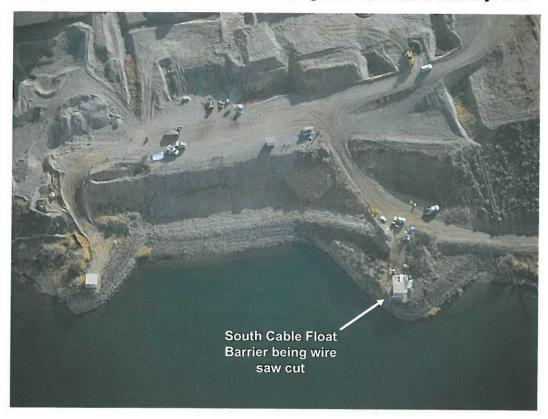
Figure 3. 181N Cable Float Barriers Being Wire Saw Cut in January 2014

Removal activities began in January 2014 when rip rap was cleared to provide a demolition crew access to set up and operate a diamond wire saw that cut them into smaller blocks that could be lifted. Figure 3 (Attachment 2) provides an aerial photograph of the south cable float barrier being cut. Six cuts through both barriers created 40 smaller blocks that were retrieved with an excavator and moved in mid-March to the basement of the 182N High Lift Pumphouse as shown in Figure 4 (Attachment 2). The water that had been used to facilitate the cutting process was collected in 55-gallon drums, solidified, and disposed of at the ERDF.

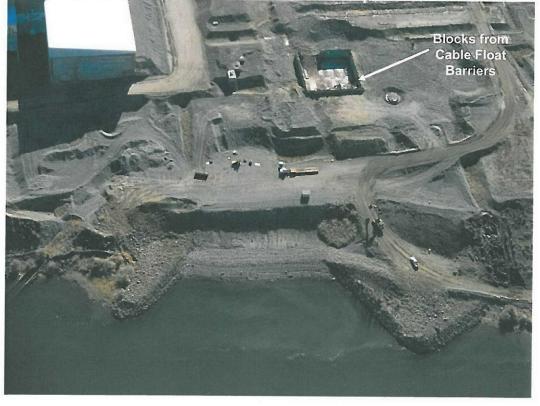
Figure 4. 181N Cable Float Barrier Areas at Completion in March 2014

The areas where the barriers had been located were visually inspected for stains and anomalies. A copy of the inspection report is provided in Attachment 5. None were observed so the rip rap that had been removed to facilitate demolition was returned and spread to blend the appearance of the points consistent with the surrounding terrain as shown in Figure 4 (Attachment 2). Since the barriers had no radiological contamination, no post demolition surveys were performed using the global positioning environmental radiological surveyor (GPERS). No post-demolition global positioning system (GPS) surveys were performed since no below-grade excavations were required for removal.

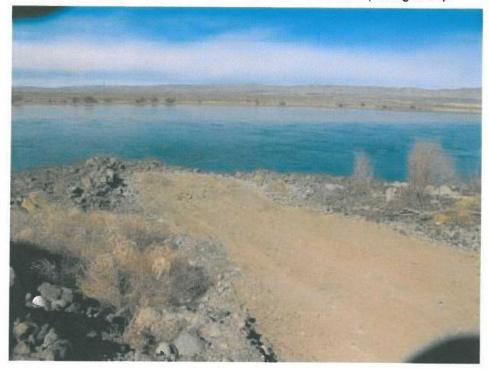
Mark. In compliance with the Removal Action Work Plan for River Corridor General Decommissioning Activities (DOE/RL-2010-34, Rev. 2), Mike Douglas performed visual inspections of the areas from where the cable float barriers were removed on March 11, 2014. He transmitted his observations and photographs to me stating no stains or anomalies were observed, with the exception of the south anchor block where the soil was darkened from localized dust suppression water used during removal. I placed his photographs in the attached Word file. Contact me if you have any questions. Clay

Photo 1. Location of former southern anchor block (facing west).

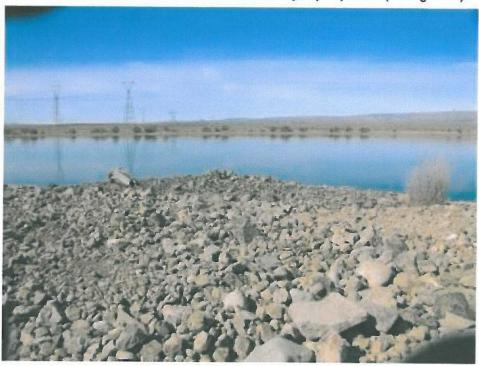
Photo 2. Southern anchor block area after rip rap replaced (facing west).

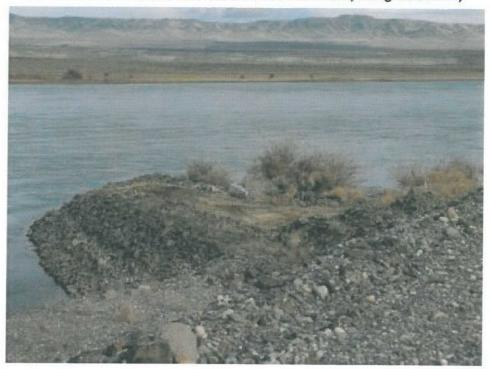
Photo 3. Location of former northern anchor block (facing northwest).

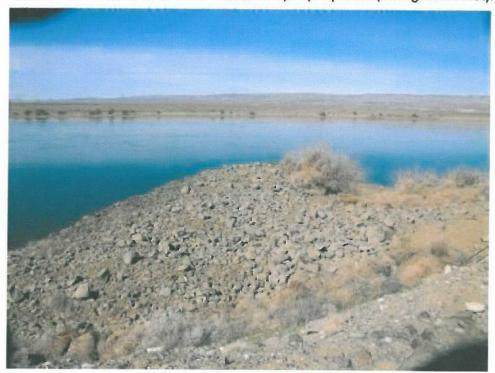
Photo 4. Northern anchor block area after rip rap replaced (facing northwest).
